# BUREAU OF SHIPS GROUP

## TECHNICAL INSPECTION REPORT

## WELDING

### OPERATION CROSSROADS

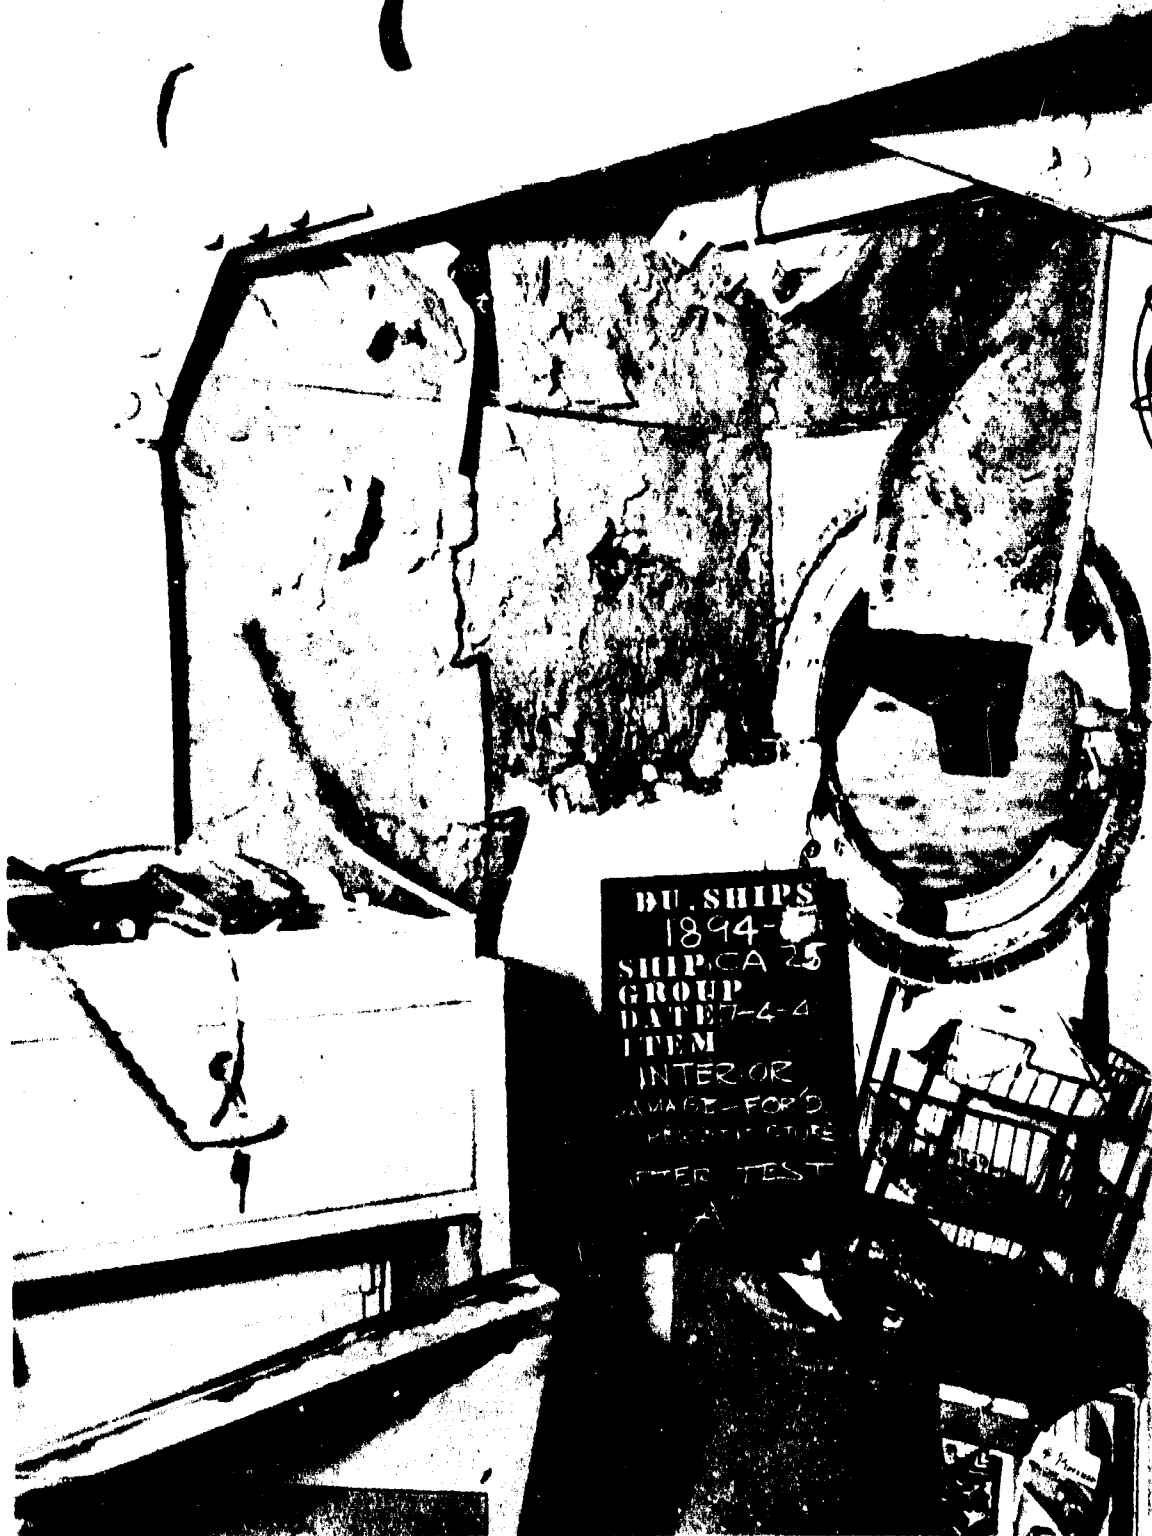
AA-CR-80-1894-5. USS SALT LAKE CITY (CA25). Damaged fibre glass insulation in forward superstructure.

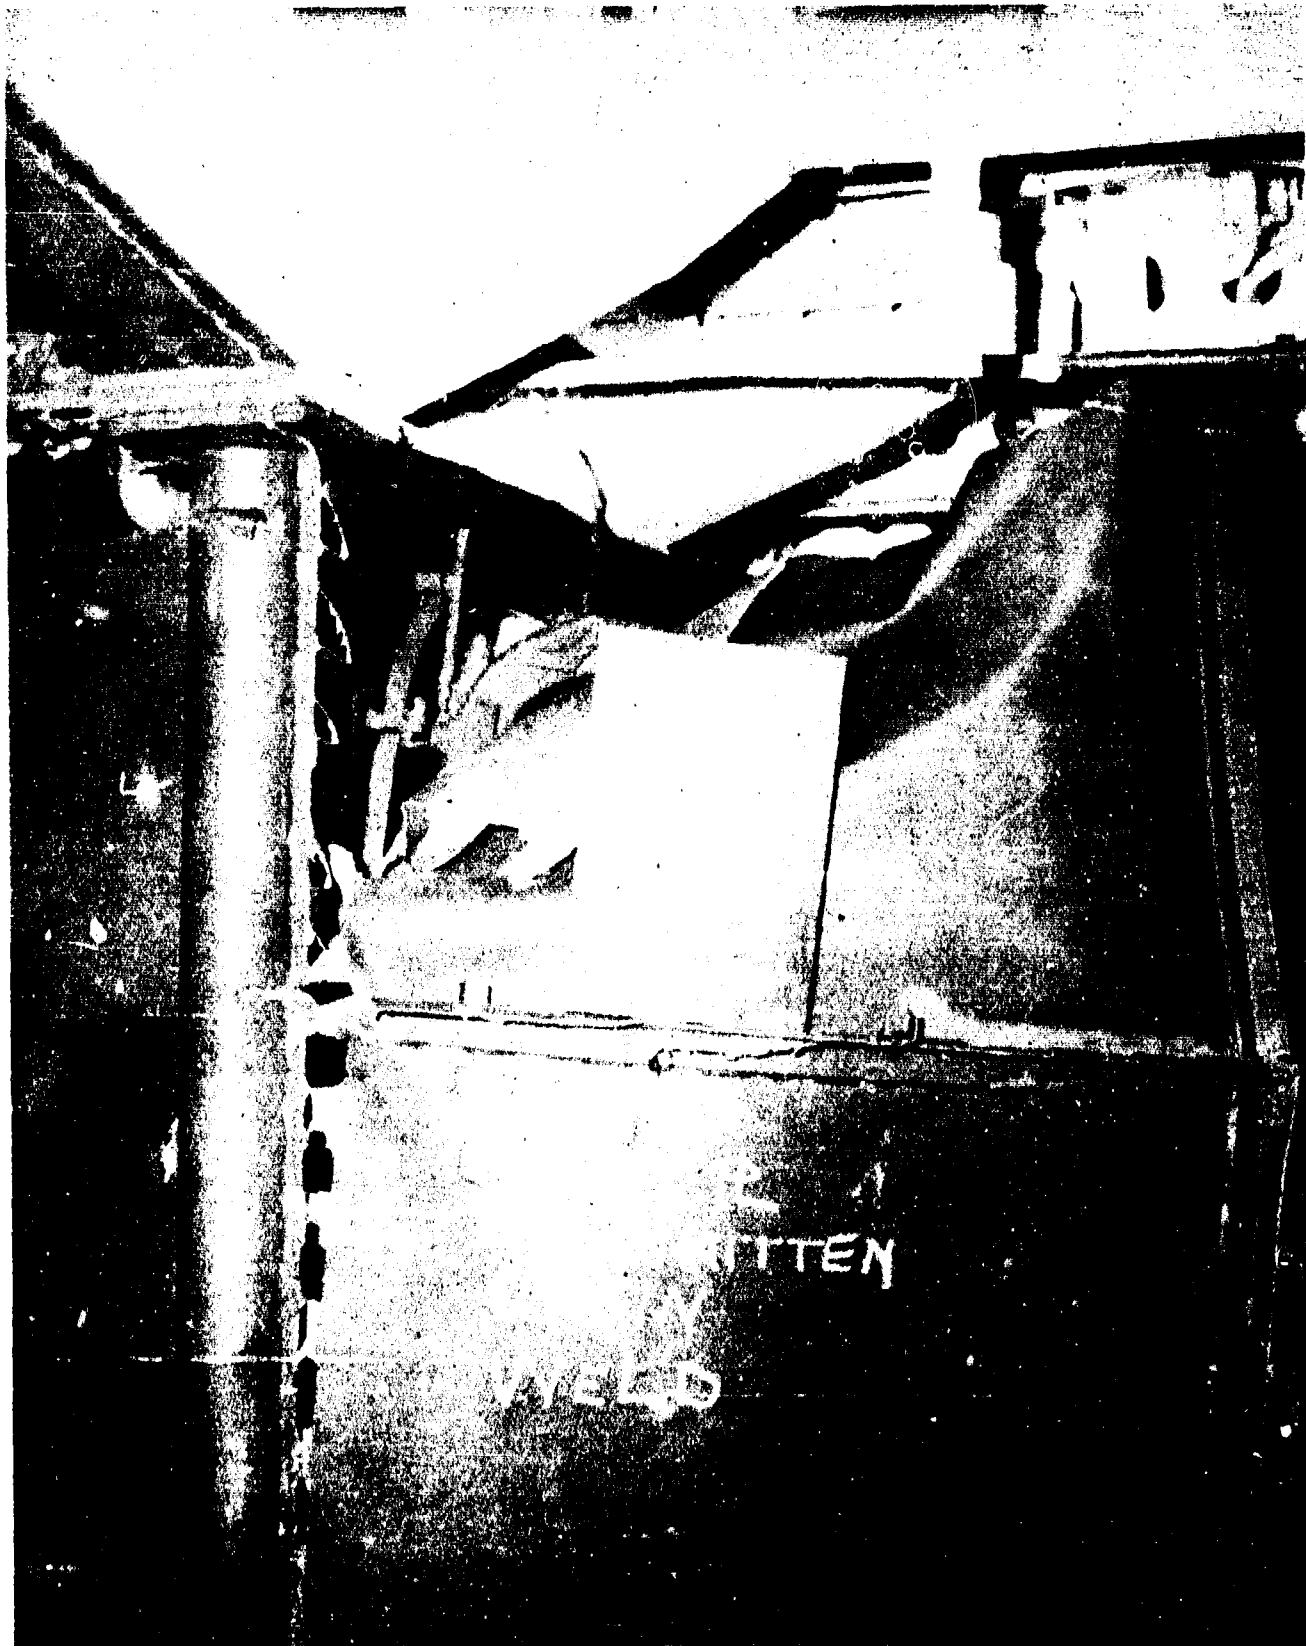
AA-CR-62-1868-4. USS SALT LAKE CITY (CA25). Failure in way of intermittent welds joining deck house plating to pipe stanchion at after end of port passage. Main deck, looking outboard and forward.
